DEPARTMENT OF TRANSPORTATION**DIVISION OF ENGINEERING SERVICES**

Contract #: 04-0120F4Cty: SF/ALA Rte: 80 PM: 13.2/13.9File #: 1.28**WELDING INSPECTION REPORT****Resident Engineer:**Siegenthaler, Peter**Address:** 333 Burma Road**City:** Oakland, CA 94607**Report No:** WIR-017350**Date Inspected:** 05-Oct-2010**Project Name:** SAS Superstructure**OSM Arrival Time:** 700**Prime Contractor:** American Bridge/Fluor Enterprises, a JV**OSM Departure Time:** 1100**Contractor:** American Bridge/Fluor Enterprises, a JV**Location:** Job Site**CWI Name:** Steve McConnell**CWI Present:** Yes No**Inspected CWI report:** Yes No N/A**Rod Oven in Use:** Yes No N/A**Electrode to specification:** Yes No N/A**Weld Procedures Followed:** Yes No N/A**Qualified Welders:** Yes No N/A**Verified Joint Fit-up:** Yes No N/A**Approved Drawings:** Yes No N/A**Approved WPS:** Yes No N/A**Delayed / Cancelled:** Yes No N/A**Bridge No:** 34-0006**Component:** OBG Section**Summary of Items Observed:**

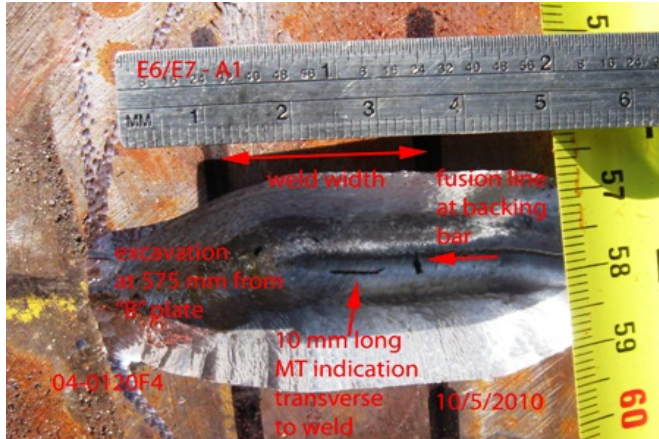
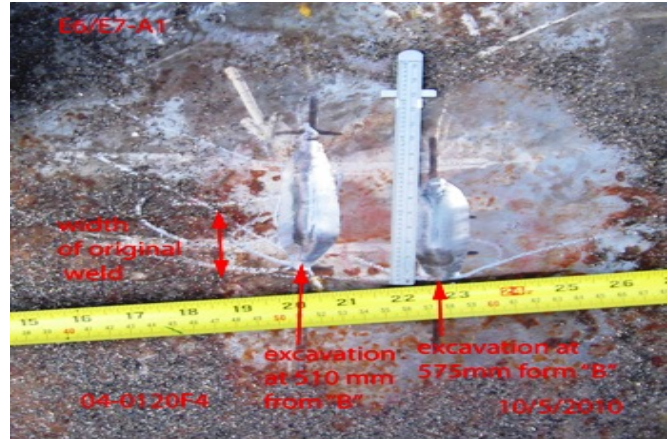
1) At weld joints E6/E7 – A1, outside the OBG section: ABF welding personnel Danny Ieraci (#3232) and Kenneth Chappell (#3833) started the excavation of two transverse Ultrasonic Testing (UT) indications. QC Inspector Steve McConnell and QCM Jim Bowers were present and monitoring the work. Please see below for details.

At weld joints E6/E7 – A1, outside the OBG section this QA Inspector was informed by QCM Jim Bowers the two transverse UT indications discovered and marked by QC personnel the previous day would be excavated to determine the type and extent of the repair. This QA Inspector observed as ABF welding personnel Danny Ieraci (#3232) and Kenneth Chappell (#3833) started the excavation of two transverse indications using a power grinder with a grinding disk and rounded burring tool. QC Inspector Steve McConnell was also present and monitoring the work. The work started at the indication located 510 mm from “B” weld and as the weld was excavated welding personnel Kenneth Chappell (#3833) would stop periodically and QC Inspector Steve McConnell would check the depth of the excavation and visually examine the area. The depth of the UT indication marked adjacent to the area was 13 mm with a length of 50 mm. At an excavation depth of 17 mm QC Inspector Steve McConnell performed and accepted a visual inspection and Magnetic Particle Testing (MT) of the excavation area. This QA Inspector performed a visual verification of the excavation which had a length of 85 mm, width of 28 mm and depth of 17 mm. Please note this was the second excavation of a repair at this location, the final excavation appeared to have a length of 65 mm within the original weld area but it was difficult to determine the exact width of the weld at this location due to the previous repair and grinding. The second indication located at 575 mm from weld “B” was excavated the same way, stopping periodically for QC Inspector Steve McConnell to check the depth and perform a visual inspection. The depth of the UT indication marked adjacent to this area was 15 mm with a length of 20 mm. At an excavation depth of approximately 15 mm QC Inspector Steve McConnell performed MT and observed a linear indication. The excavation continued stopping periodically for QC Inspector Steve McConnell to perform MT inspections. At an excavation depth of 21 mm the MT indication was longer and more pronounced than what it was previously. With the excavation at this depth an indication which appeared to be the fusion line between the backing bar and base material was visible. QCM Jim Bowers elected to stop further excavation at this time stating he would put together a repair procedure and submit it for approval prior to proceeding. The excavation at this time had a length of 70 mm, width of 29 mm and was 21 mm deep. Please see photos below.
